<b>Project</b>	<b>Support with transport evidence base for the Loxwood Neighbourhood Plan</b>	<b>Reference</b>	47060782
<b>Subject</b>	Briefing Note – Evidence and Findings of Transport Analysis		
<b>Prepared by</b>	Richard Corbin, Graduate Transport Planner	<b>Date</b>	May 2013
<b>Reviewed by</b>	Colin Romain, Principal Transport Planner	<b>Date</b>	May 2013
<b>Approved by</b>	Jonathan Crabb, Head of Transport Planning for Development - South	<b>Date</b>	May 2013

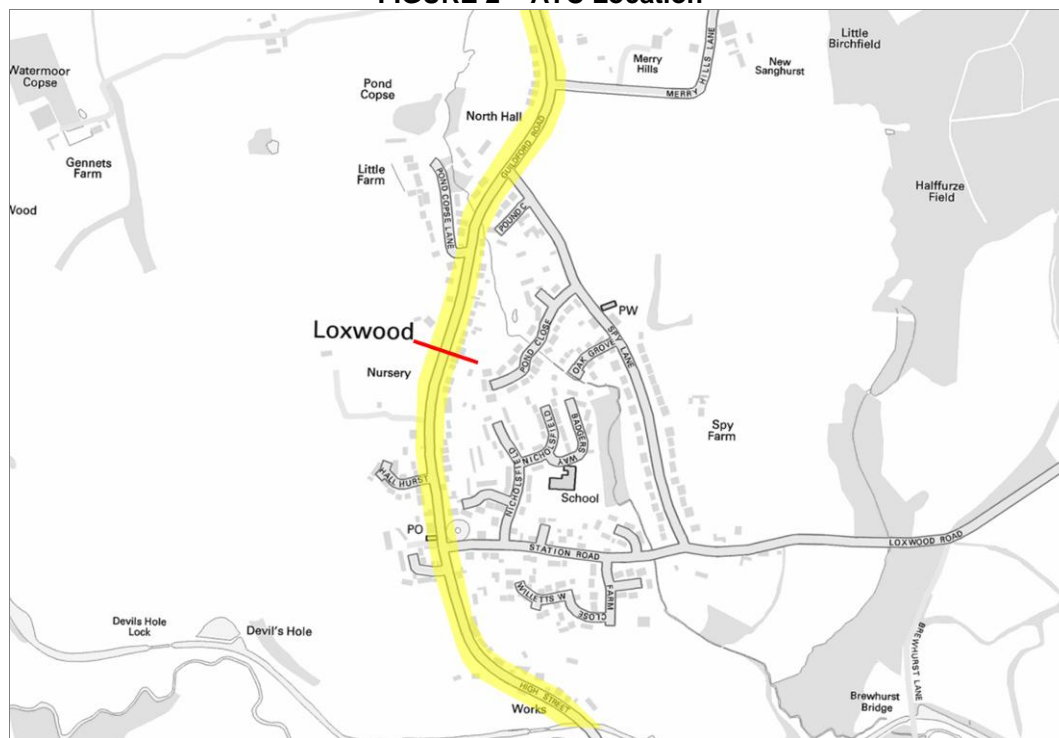
**FIGURE 2 – ATC Location**

To expand upon the existing data and to present a more accurate representation of traffic speeds, an automatic traffic count (ATC) was carried out on the B2133. This was in place for a period of 7 days, commencing Tuesday 7<sup>th</sup> May 2013 and recorded speed data 24 hours a day. In accordance with DfT guidelines, traffic data recorded in the month of May represents 'neutral' traffic conditions. The location of the ATC on the highway network can be seen in **FIGURE 2** and **PHOTO 1**.

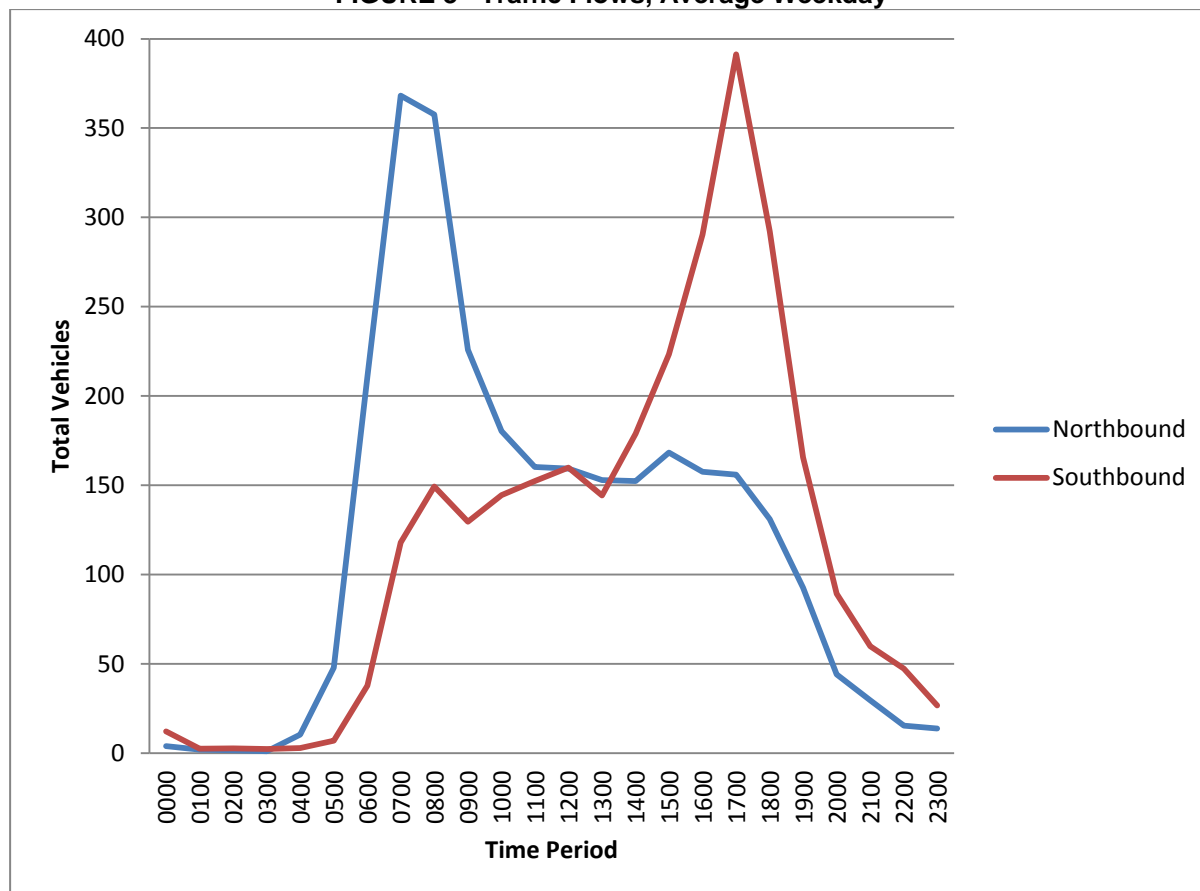
**FIGURE 3 –Traffic Flows, Average Weekday**

During Monday to Friday, the peak periods and tidal flow are clearly evident, with the AM peak (7am – 10am) traffic heading in north broadly towards the Guildford, Woking, London and the Aldershot Urban Area, and the PM peak (4pm – 7pm) traffic returning south.

From the start of the AM peak period (7am) to the end of the PM peak period, the average combined traffic flow is 395 vehicles per hour. The maximum observed combined traffic flow during the same timeframe was 547 vehicles, occurring between 5pm and 6pm.

The estimated link capacity of the road has been calculated using DfT guidance, which based on a carriageway width of 6.75m (as observed on site) and road type of 'Urban All Purpose 3' suggests a maximum throughput of 1,110 vehicles per hour. The graph demonstrates that the busiest peak is during the evening, where approximately 400 vehicles head southbound on the B2133. The road is therefore operating at around 36% of capacity.

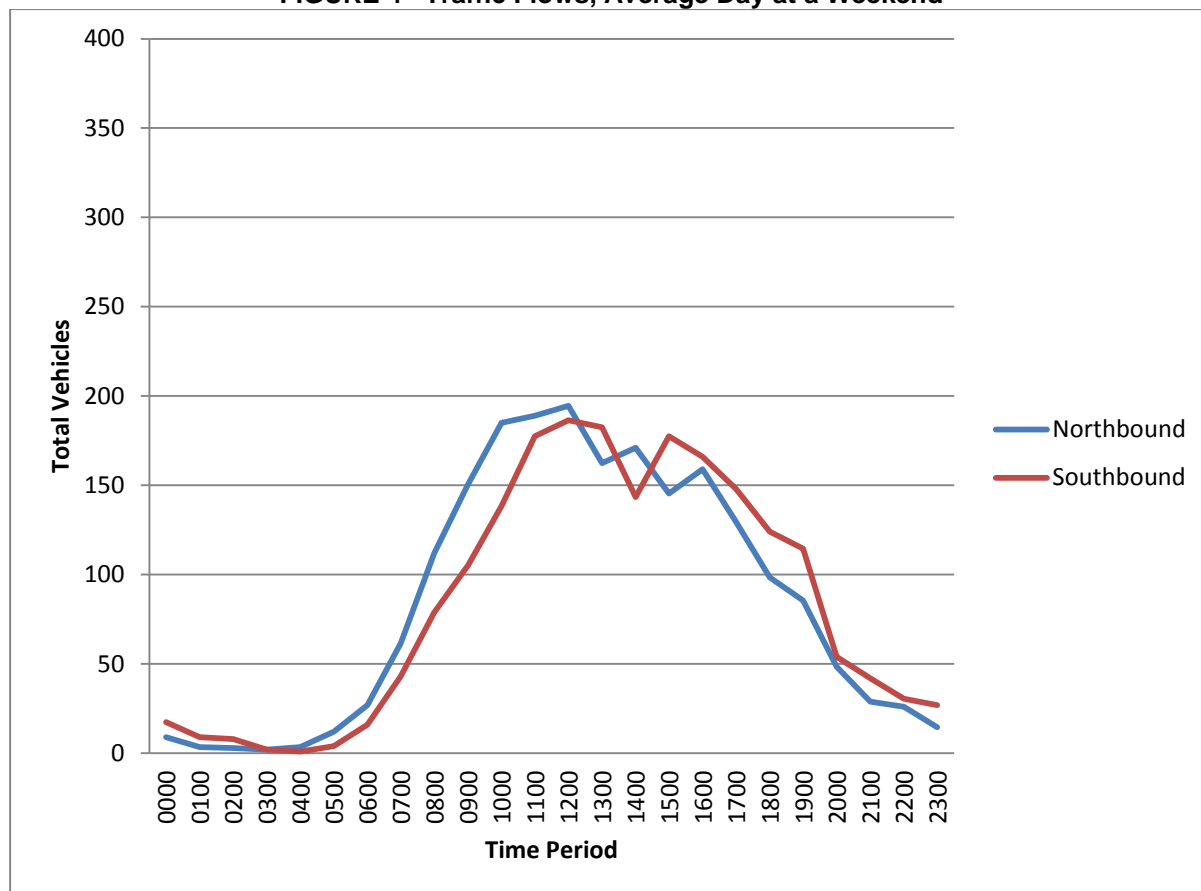
**FIGURE 4 –Traffic Flows, Average Day at a Weekend**

In contrast to the Monday to Friday traffic flows, the ATC data indicates that the weekend operates with a broad peak of two-way traffic between 10am and 3pm. Referring to the aforementioned 1,110 vehicle capacity, the peak flow of approximately 200 vehicles in a single hour indicates that the road is operating at around 18% of capacity at weekends.

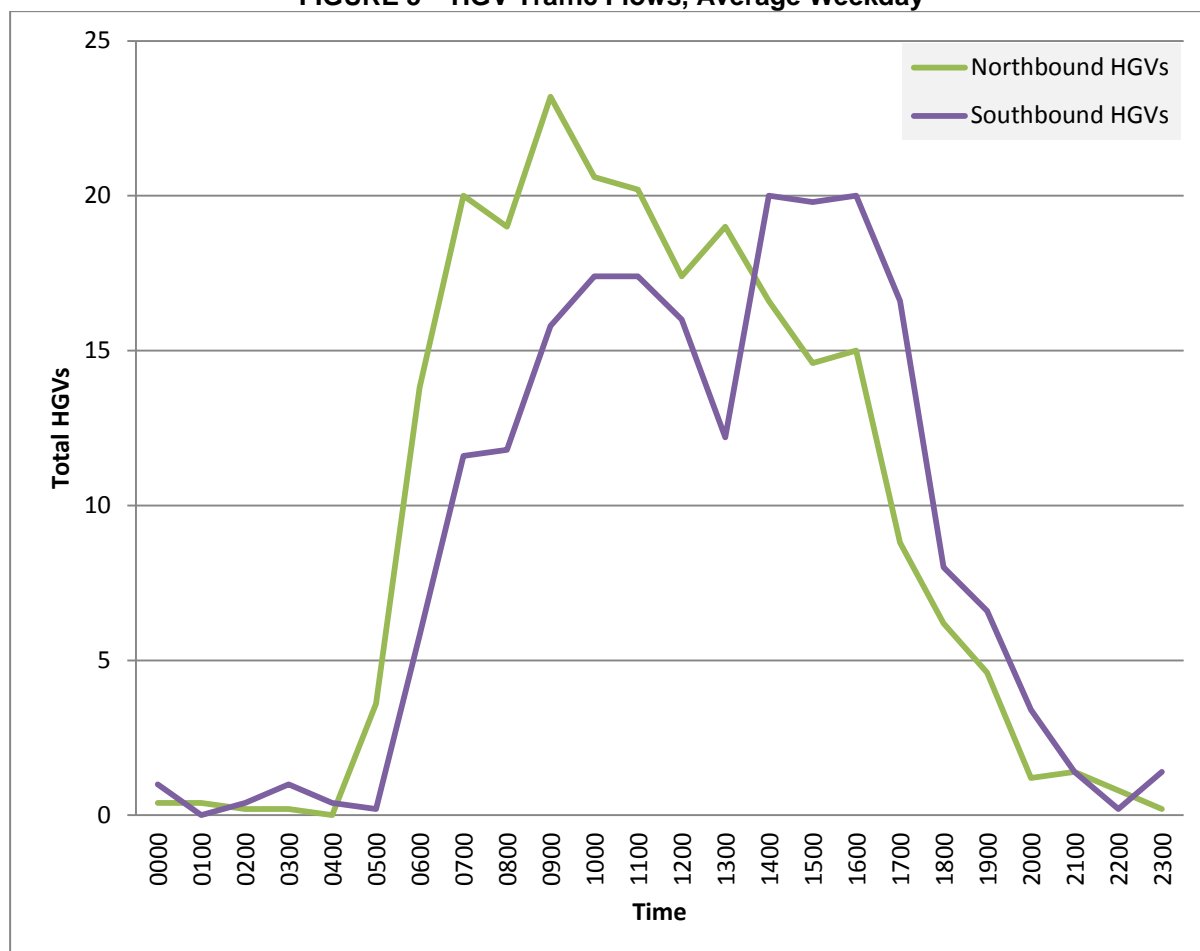
**FIGURE 5 – HGV Traffic Flows, Average Weekday**

The number of HGVs passing through the village during weekdays peaks at 23 in the northbound direction, at 9am. The equivalent peak for the southbound flow is between 2pm and 4pm, with 20 HGVs per hour at these times. The total HGV movements along the B2133 on an average weekday is approximately 227 northbound and 208 southbound, or 436 combined; 7.7% of all traffic.

The greatest number of HGVs in a single hour was recorded between 9am and 10am, with a combined flow of 39 HGVs; equating to 11% of all traffic during that time period. Further detail regarding HGV movements throughout an average weekday is shown in **FIGURE 6**.

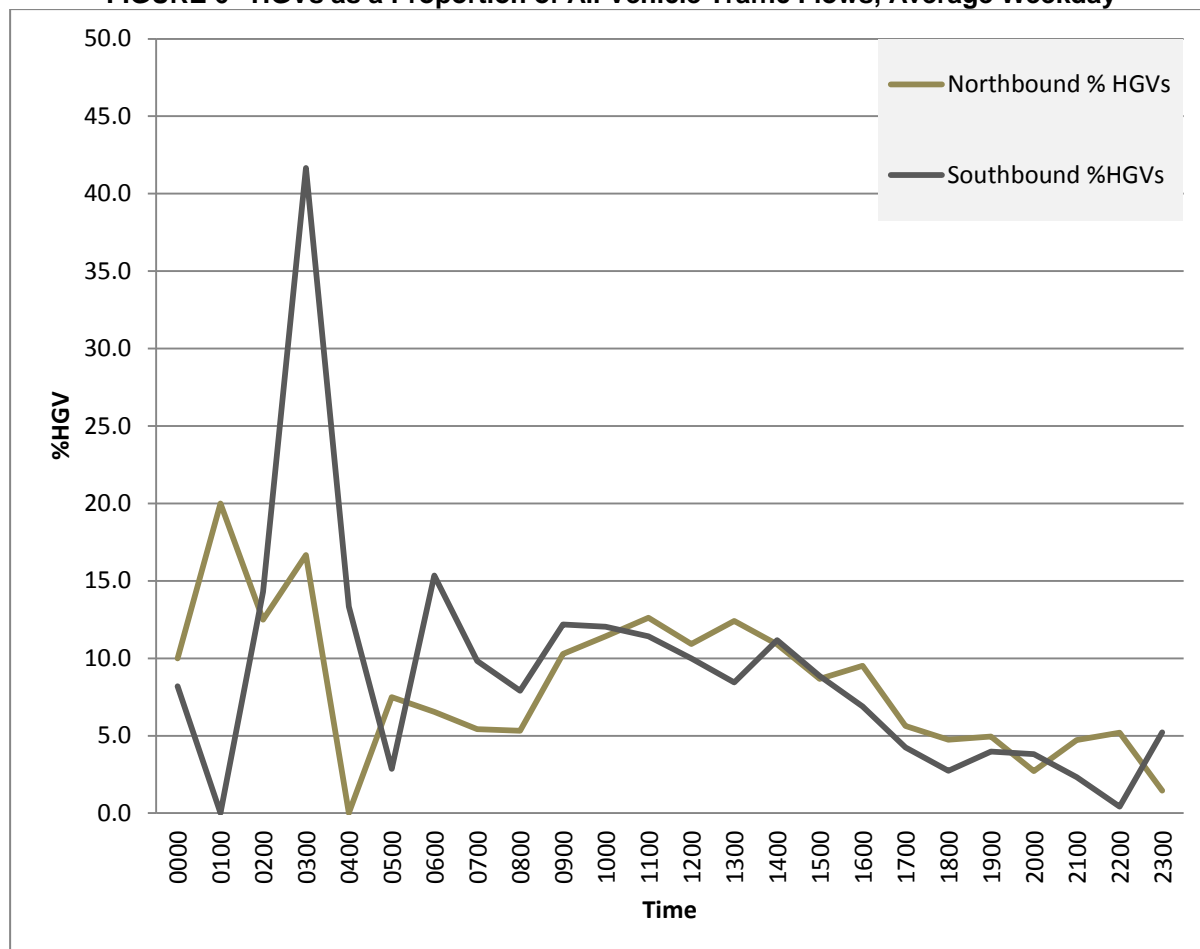
**FIGURE 6 –HGVs as a Proportion of All Vehicle Traffic Flows, Average Weekday**

From the start of the AM peak period (7am – 10am) through to the end of the PM peak period (4pm – 7pm), the average proportion of HGVs against all traffic in the northbound direction equates to 9%. For the southbound movement, the average proportion is 8.8%.

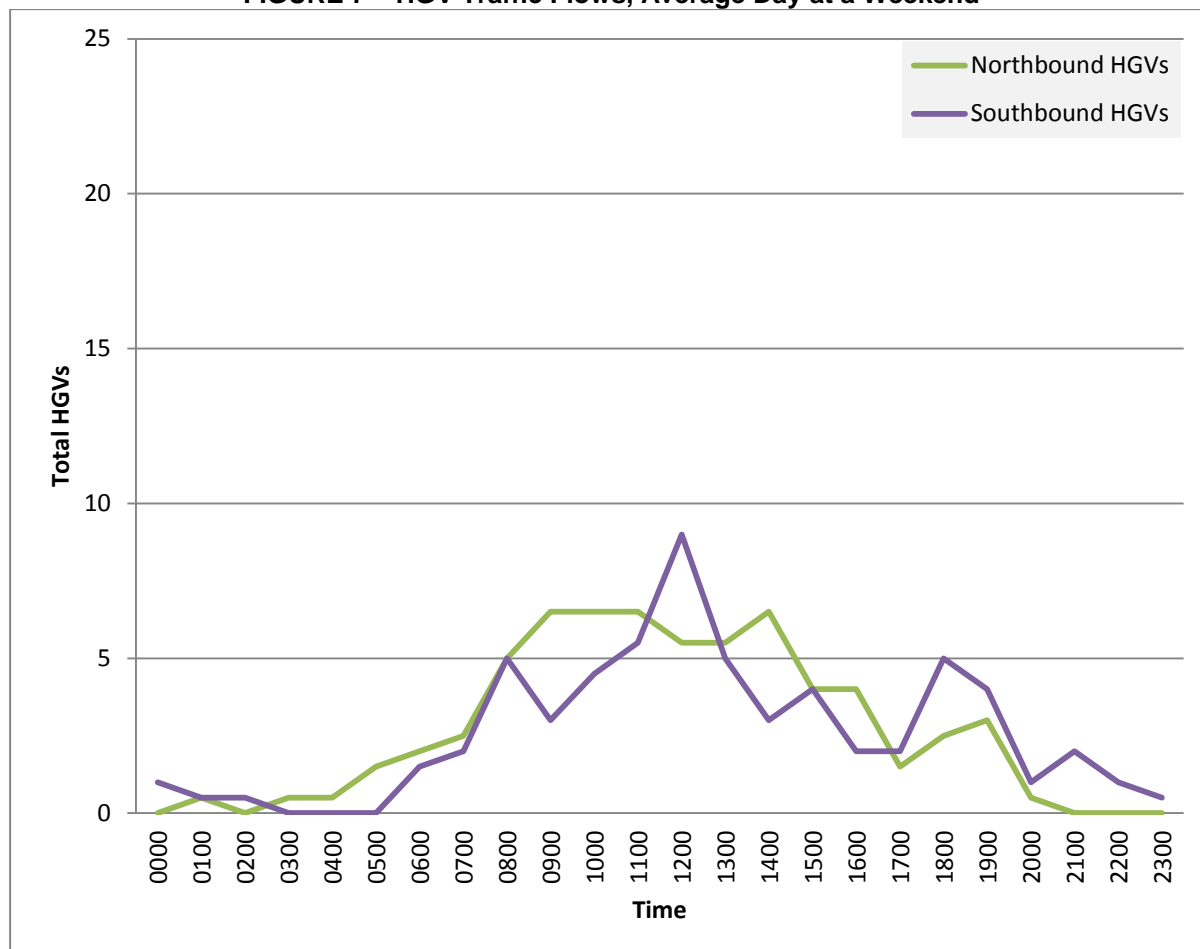
**FIGURE 7 – HGV Traffic Flows, Average Day at a Weekend**

The HGVs passing over the ATC on the B2133 during the weekend peaked at 7 in the northbound direction, between 9am and 2pm. The peak southbound flow of 9 HGVs occurred at midday. The total HGV movements on an average day at the weekend is approximately 65 northbound and 62 southbound, or 127 combined; 3.1% of all traffic.

The greatest number of HGVs in a single hour was recorded between 12pm and 1pm, with a combined flow of 15 HGVs; equating to 3.9% of all traffic during that time period or approximately 1 HGV every 4 minutes. Further detail regarding HGV movements during an average day at a weekend is shown in **FIGURE 8**.

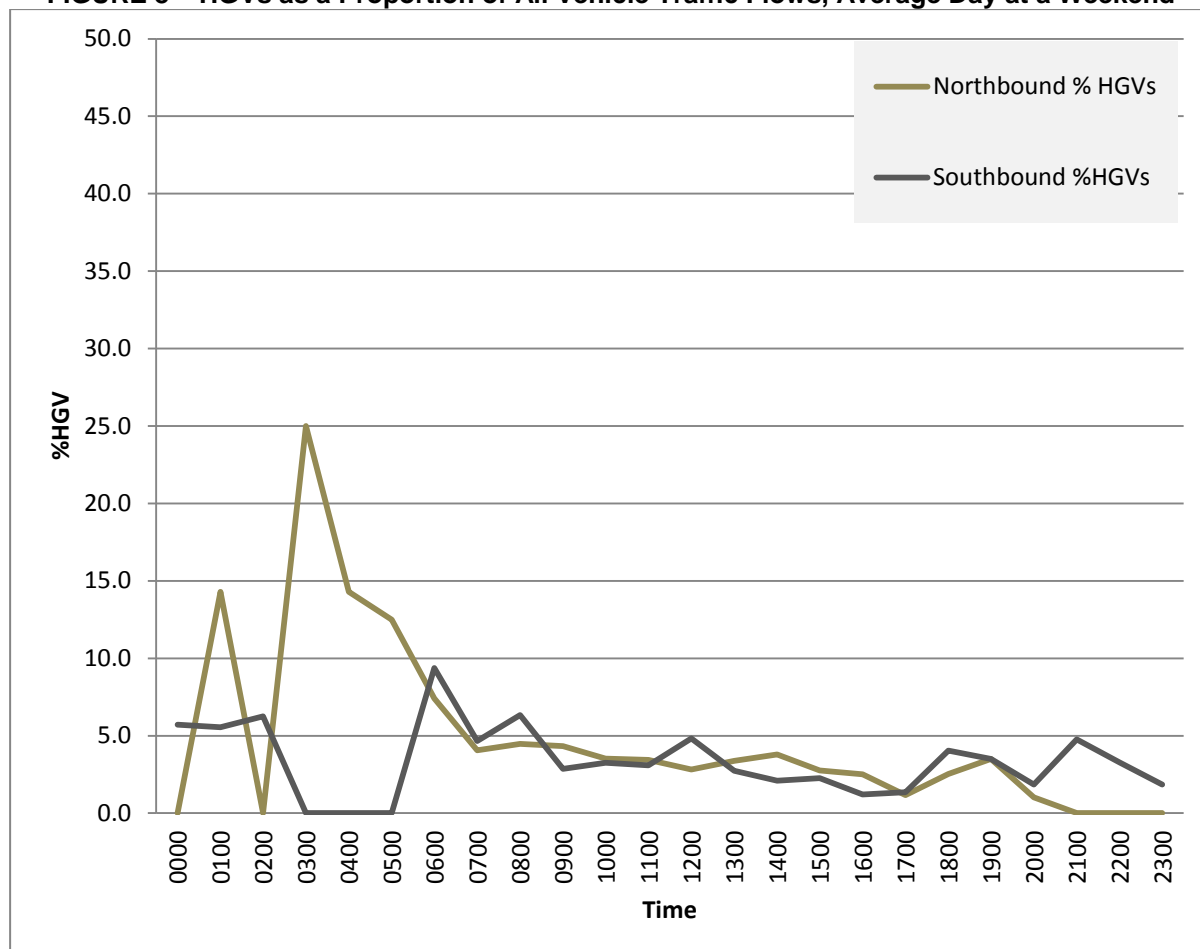
**FIGURE 8 – HGVs as a Proportion of All Vehicle Traffic Flows, Average Day at a Weekend**

From the start of the AM peak period (7am – 10am) through to the end of the PM peak period (4pm – 7pm), the average proportion of HGVs against all traffic in the northbound direction equates to 3.2%. For the southbound movement, the average proportion is 4%.

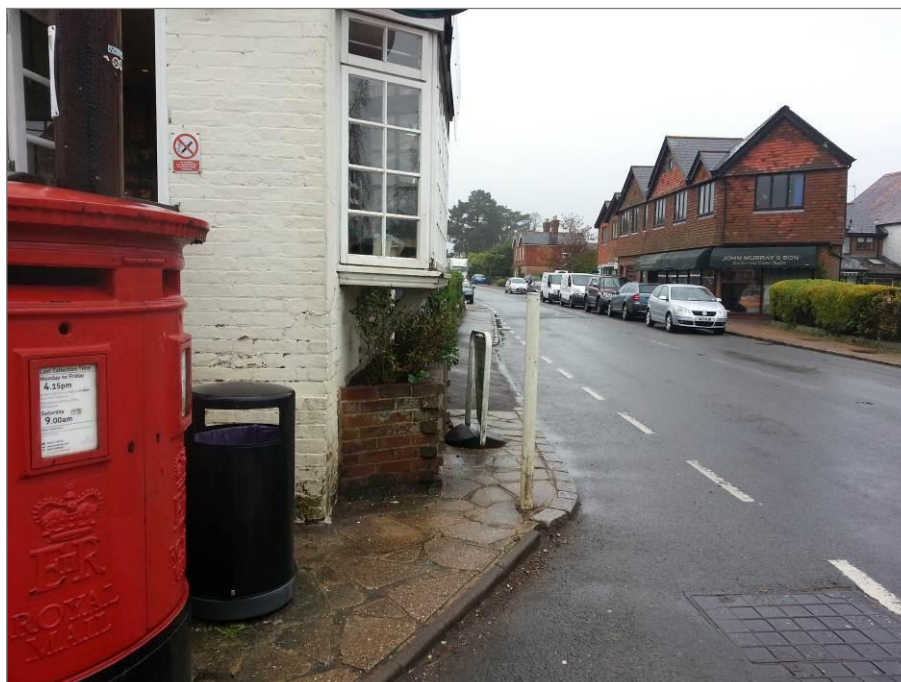
**PHOTO 2 – Poor Pedestrian Environment outside Post Office**

In addition, the pedestrian environment along the length of the road suffers from narrow sections of footway and overgrown hedges between survey points 1.1 to 1.6. The pedestrian environment is particularly restricted outside the Post Office, an area of the village which is likely to experience relatively high levels of footfall. This is illustrated in **PHOTO 2**.

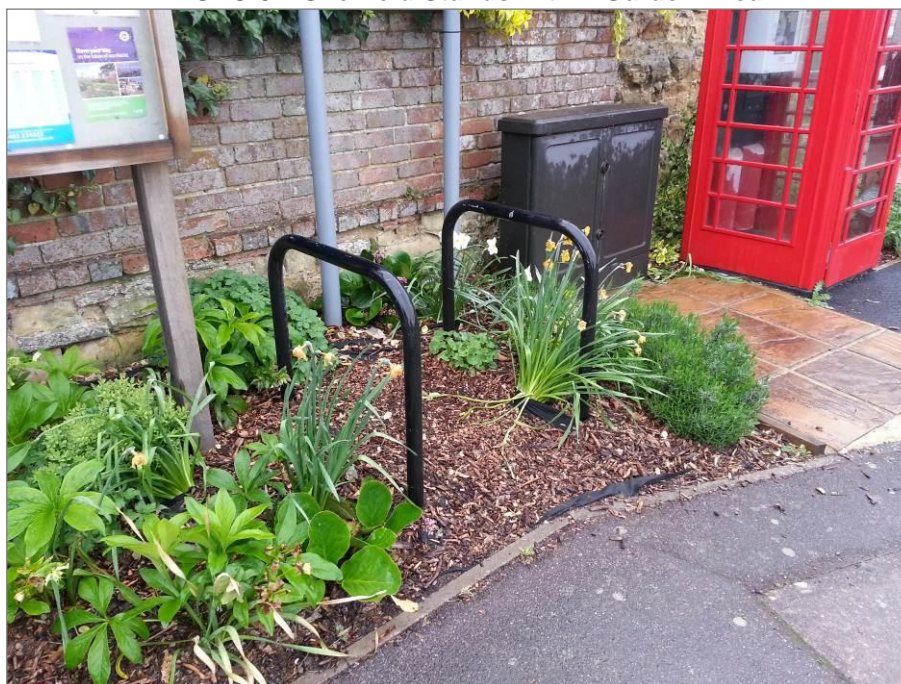
**PHOTO 3 – Sheffield Stands within Garden Area**

A number of other observations were also noted along the road. The bus lay-by outside the Post Office was frequently used as informal car parking for those briefly visiting the shop, with no formal parking available in the immediate vicinity. Adjacent to the bus stop, two Sheffield stands for bicycles were present amongst a garden area, as shown in **PHOTO 3**, a situation which may discourage cyclists from using these facilities.

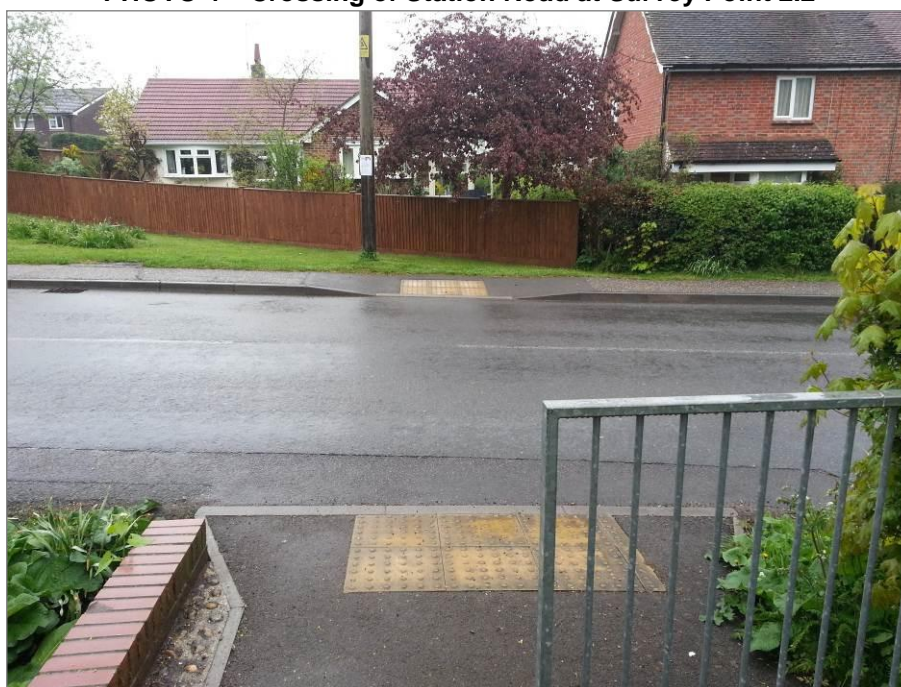
**PHOTO 4 – Crossing of Station Road at Survey Point 2.2**

The pedestrian environment consists of a footway on the northern side of the road, with the southern side comprising a verge and drainage channel for 3 of the 5 survey points, as illustrated in **TABLE 6**. At survey point 2.2 there is a pedestrian footway linking Station Road with the residential areas of Willetts Way and Farm Close, which provides a short cut for pedestrians and a facilitated crossing point, shown in **PHOTO 4**.

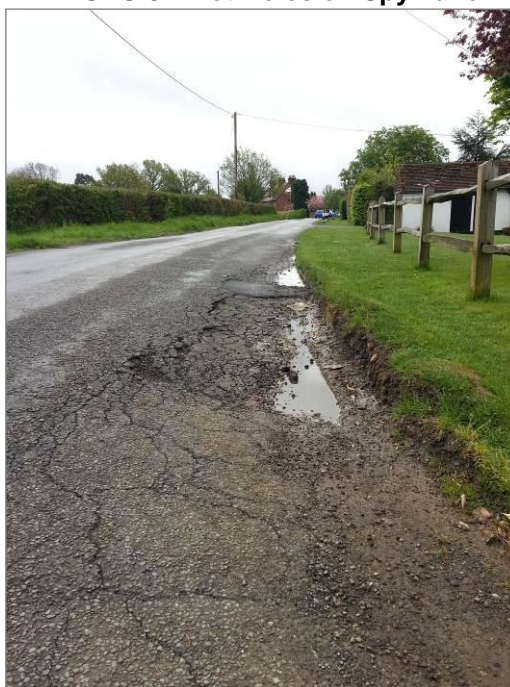
**PHOTO 5 – Pot Holes on Spy Lane**

As shown in **TABLE 7**, with the exception of a short stretch of footway at survey point 3.1, Spy Lane does not have footways. As such, on-street parking can sometimes cause pedestrians to need to walk in the road. Furthermore, the road surface is poor at a number of locations, which presents hazards for pedestrians, as shown by the pot holes in **PHOTO 5**.

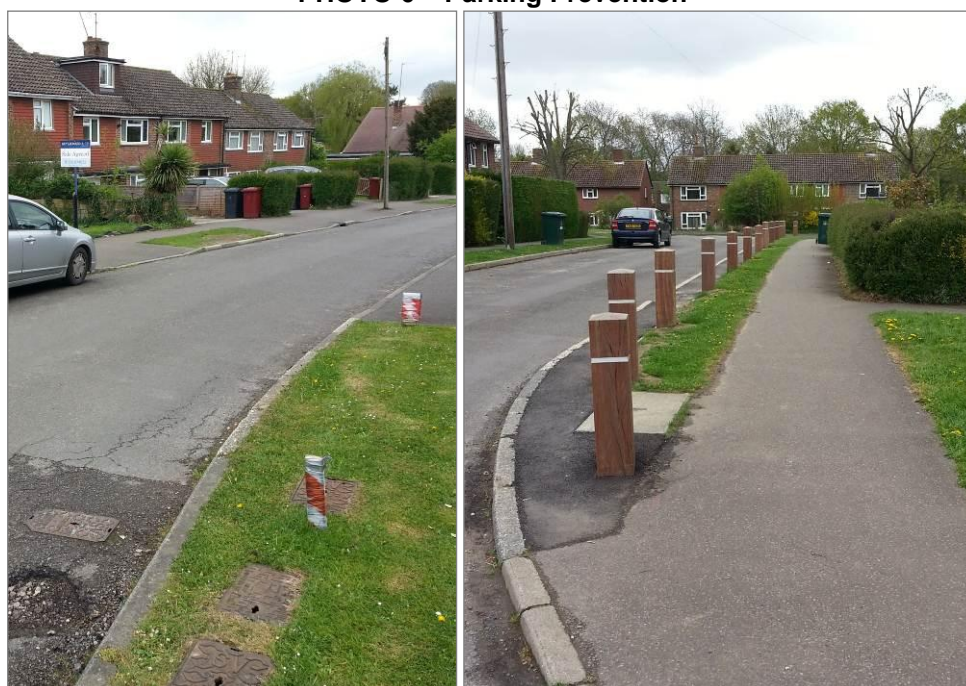
**PHOTO 6 – Parking Prevention**

Both the local authority and residents have implemented measures to prevent parking on the grass verges at the edge of the road. The local authority has installed bollards in the immediate vicinity of the school, to facilitate two-way vehicle movement. Residents have used various obstacles outside their properties to prevent temporary and informal parking. Where obstacles were not present, verges were parked on and footways were also blocked – see **PHOTO 6**.

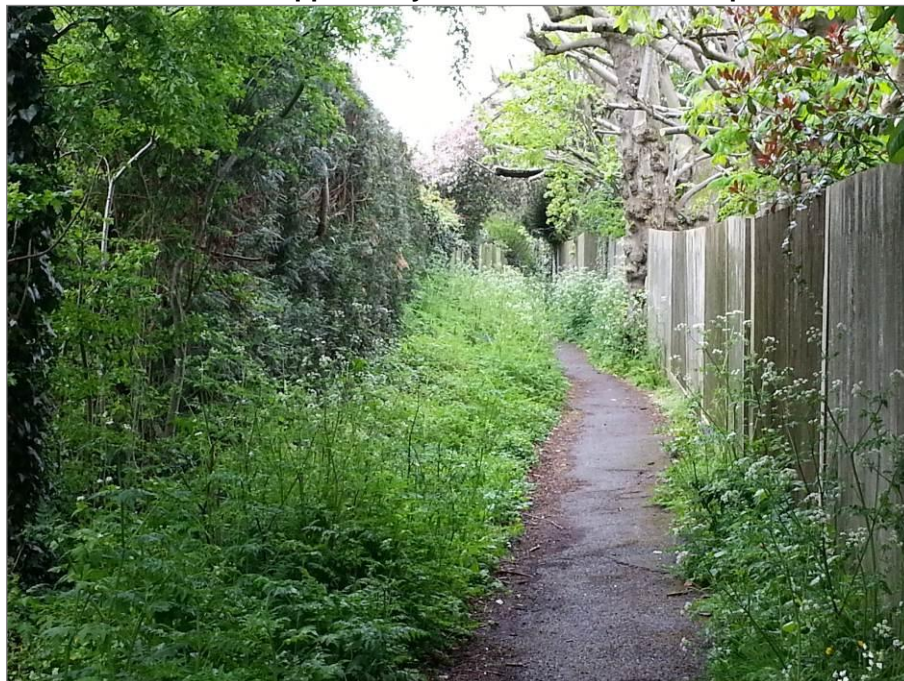
**PHOTO 7 - Opportunity to Enhance Public Footpath**

The public footpath is poorly maintained and unlit, as shown in **PHOTO 7**, and this may discourage use. Notably, the width of the footpath (900mm) is below the absolute minimum DfT guideline of

1000mm and may therefore be difficult to navigate with pushchairs or prams. In addition, throughout the village there is a lack of signage for pedestrians to clearly outline walking routes to school.
